Application of Geophysical Survey for Subsurface Investigation of an Erected Multistory Building in Southwestern Nigeria

Omowumi Ademila

Department of Earth Sciences, Adekunle Ajasin University, Akungba-Akoko, Nigeria

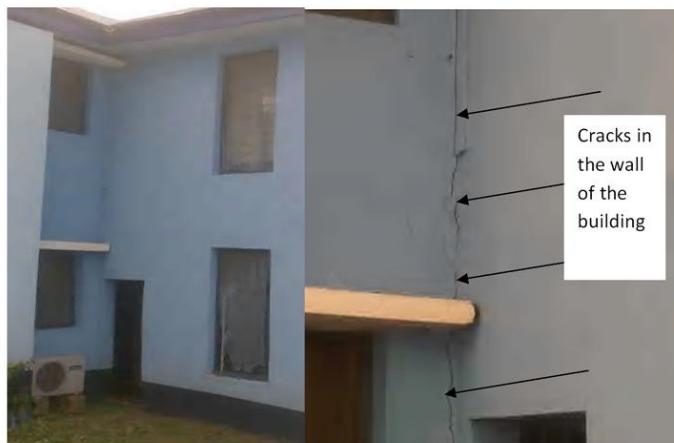
Fig. 1.Crack from first to the ground floor of the storey building.

ranging from 42 ohm-m to 151 ohm-m and thickness varying from 1.7 m to 9.5 m corresponding to area of greatest water saturation in the area could be attributed to the development of cracks in the building. The electrical resistivity of a formation is directly related to the nature, quantity, quality and distribution of the formation water (Adewumi and Olorunfemi, 2005). The structural failure related cracks on the building is also due to the presence of near surface bedrock depressions, occupied by low resistivity weathered materials typical of water-saturated clays which is unsuitable construction materials.

varies from 1.7 m to 9.5 m. Fracture zones (F-F') identified constitute the major faulted zones underlying the building which are responsible for its instability. Structural failure related cracks on the building is due to the presence of these underlying weak, active clay at shallow depths and the occurrence of sub-surface features occupied by low resistivity weathered materials which is very unsuitable for erecting a building. Future planning for the construction of new buildings in the area should be erected on the fresh bedrock with pile foundation since the fresh bedrock lies beneath the fractured basement to ensure integrity of buildings.
